Magnolia Marine Transport Tank Barge MM53 Case Study January 2006

**Jim Smith – Magnolia Marine Transport
Andrew Milanes – Environmental Science
Services, Inc.**

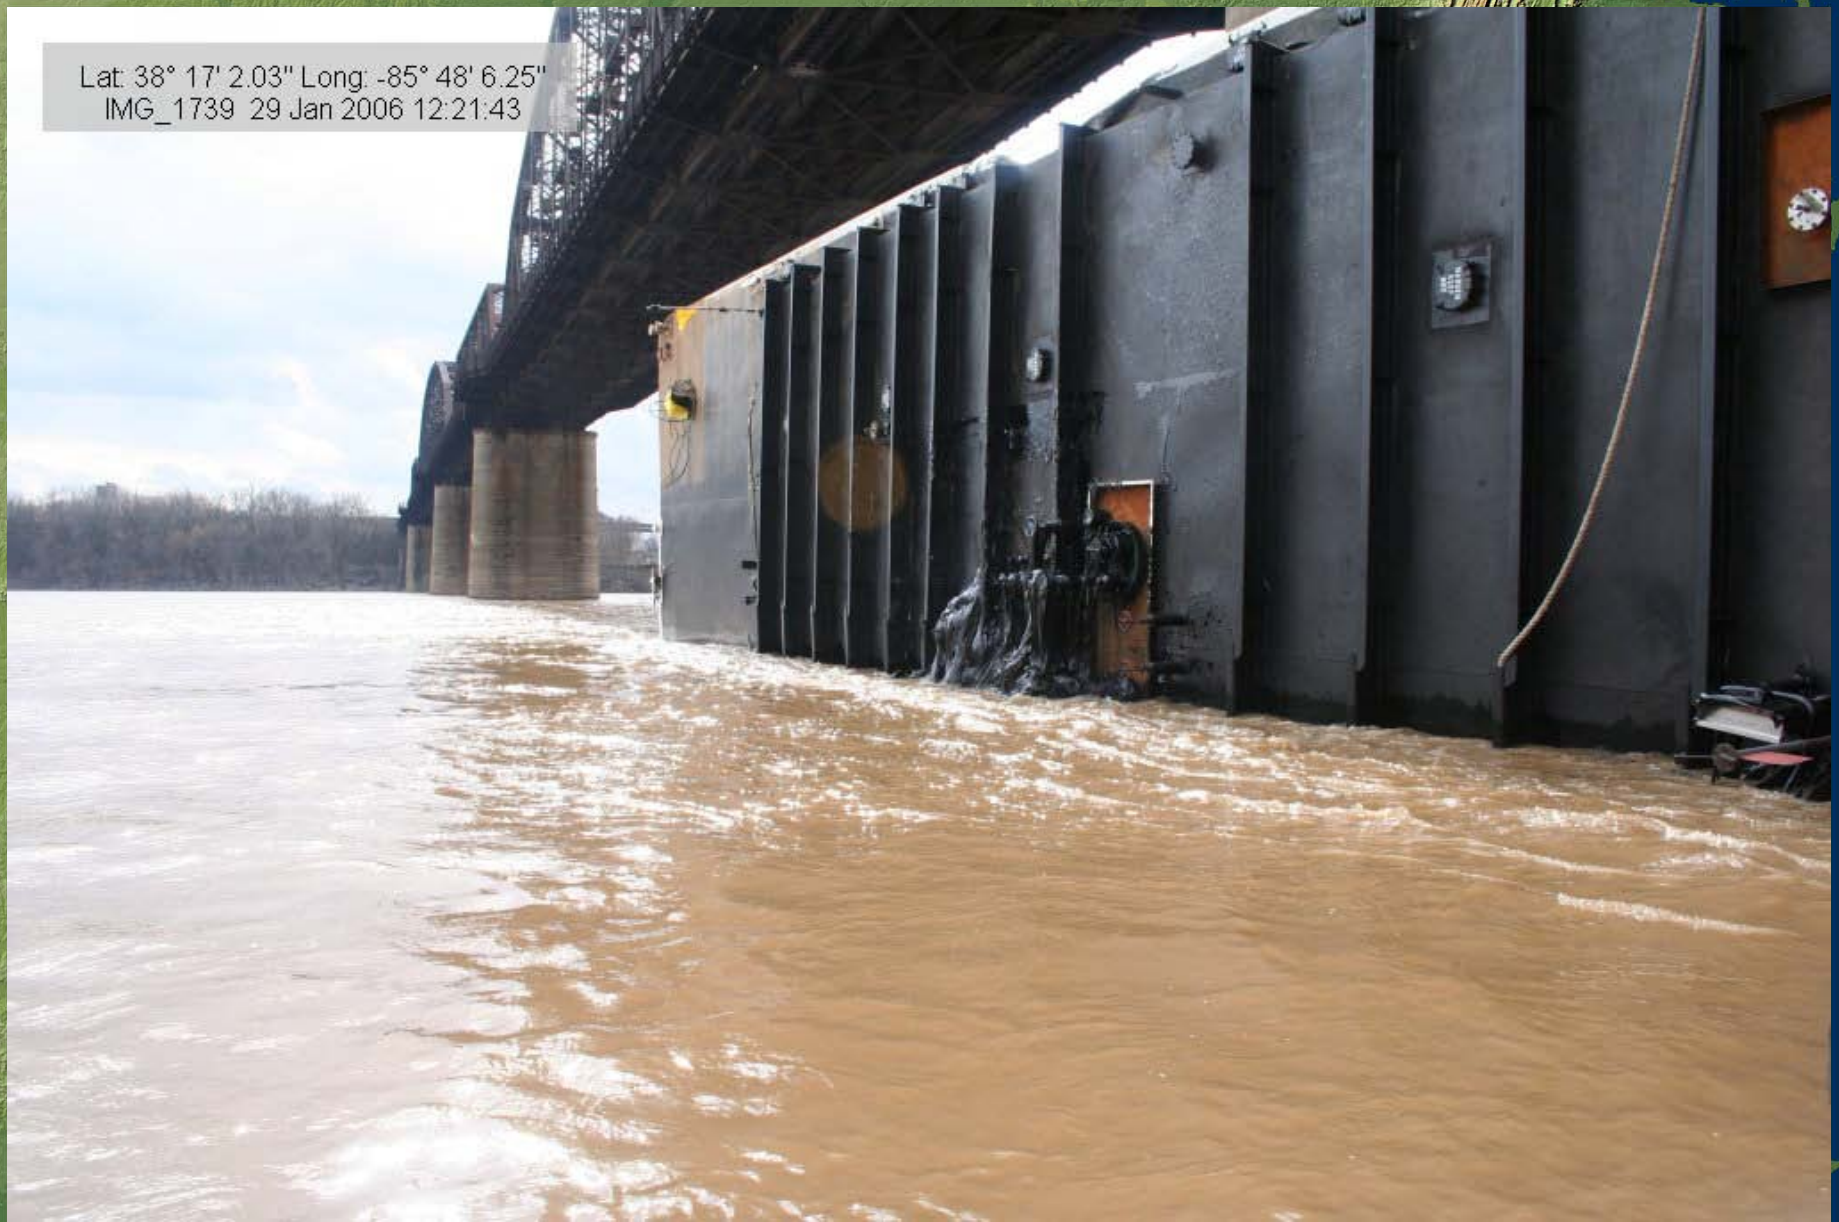
Lat: 38° 17' 2.03" Long: -85° 48' 6.25"
IMG_1739 29 Jan 2006 12:21:43

- After passing over the McAlpine Dam, the MM53 strikes the right descending bank of the Ohio River.
- The MM53 then travels downriver, perpendicular to the river flow, and strikes the K&I bridge.
- The MM53 is pinned between two piers of the K&I bridge at river mile 607.4.

- The barge begins taking on water on the port side due to the high current.
- The force on the port side eventually flips the MM53 90 degrees, and is pinned between the piers.

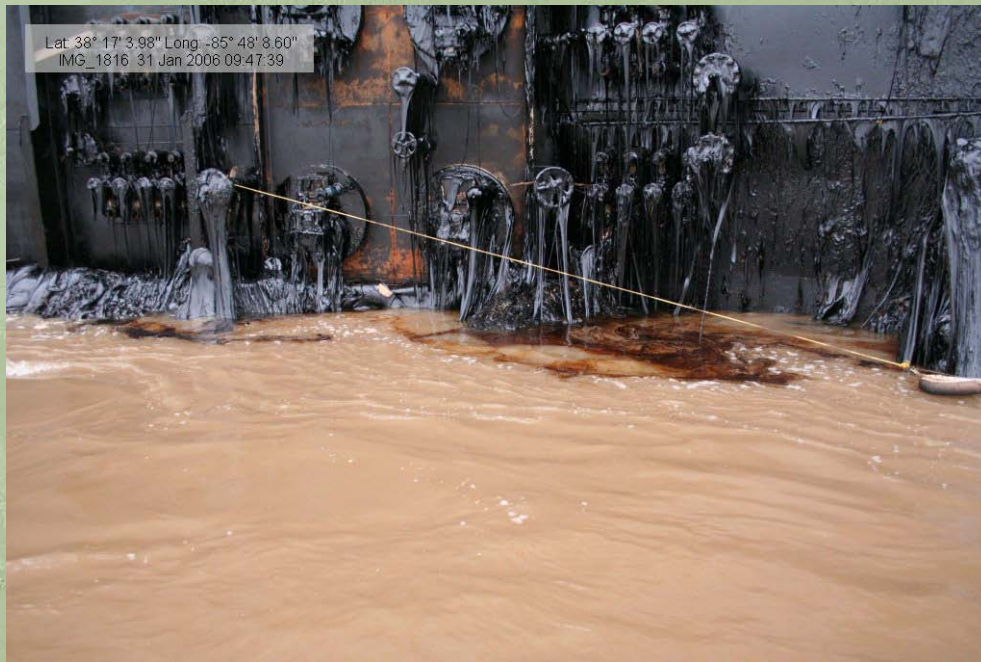
- 5,000 gallons of diesel were released from the port tank almost immediately when the barge flipped 90°.
- 4,000 gallons of thermal heating oil was released from the damaged heating coils.
- Small amounts of heating oil continued to leak from the damaged piping for about a week.

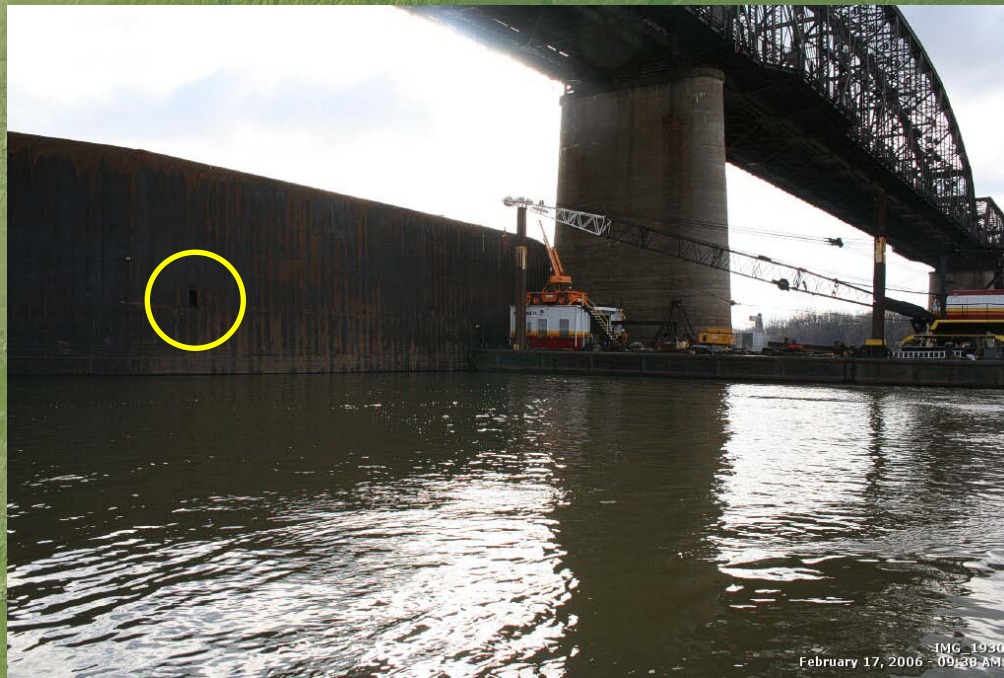
IMG_1930
February 17, 2006 - 09:20 AM

“Windows” cut into
bottom of MM53
for cargo lightering.

- Cut windows in bottom (back side) of barge to install valves into cargo compartments.
- Use these new valves to drain reheated cargo into the MM54B.
